Application Note AN M152

FTIR Microscopy in Automotive Industries: Large Sample Analysis

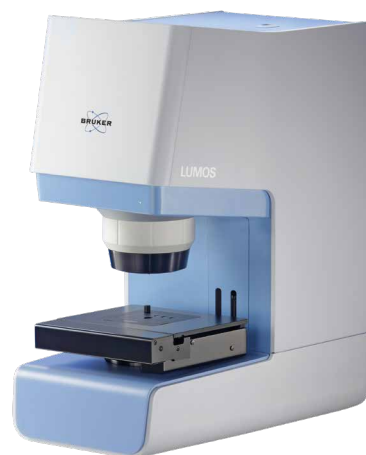
The LUMOS is a sturdy FTIR microscope that is self-explanatory in its workflow.

It offers an excellent optical inspection of microscopic samples and yields valuable chemical information as well.

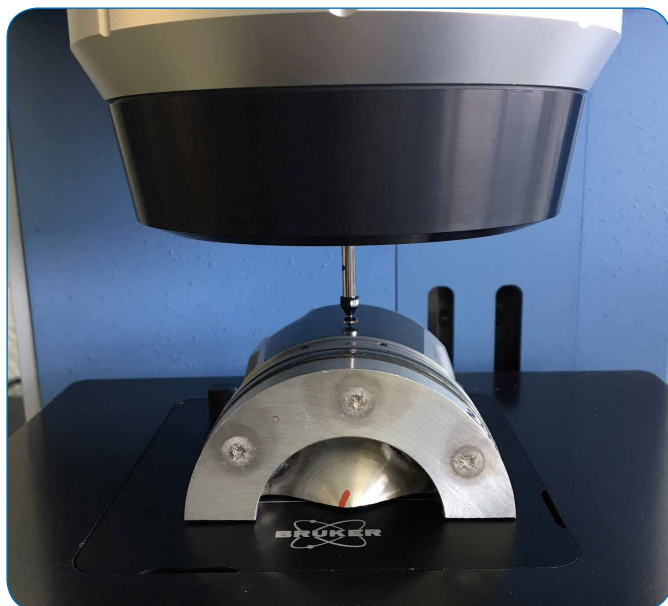
Figure 1: Halved piston from a diesel combustion engine.

Example #1: Surface Analysis of a Piston from a Combustion Engine

This piston from a diesel engine has only been in operation for a short time. To assess the impact the brief usage had on its graphite coated surface, the piston was investigated by FTIR microscopy. Since the preparation for a sample piece made entirely of metal is particularly difficult, the large working distance of the LUMOS proved advantageous. The piston was only halved, and the surface directly analyzed by ATR FTIR.
