Application Note AN M77

Contactless analysis of mural paintings with a new portable FT-IR analyzer

Surface analysis of mural paintings by Francesco Albani in Bologna, Italy (End of XVI century)

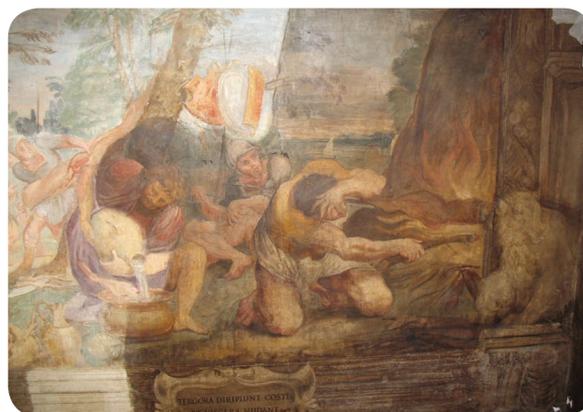
Figure 1: Mural painting by Francesco Albani in Bologna, Italy, during restoration process ^[1].

The ALPHA FT-IR spectrometer proved its high potential during the restoration of mural paintings by Francesco Albani in Bologna, Italy (Figure 1 and 3). Selected areas of the mural paintings were analyzed before and after cleaning in order to decide on the best cleaning method and solvent or if the treatment is really effective. The spectra collected directly on the surface of the mural painting were compared to reference spectra from the library.

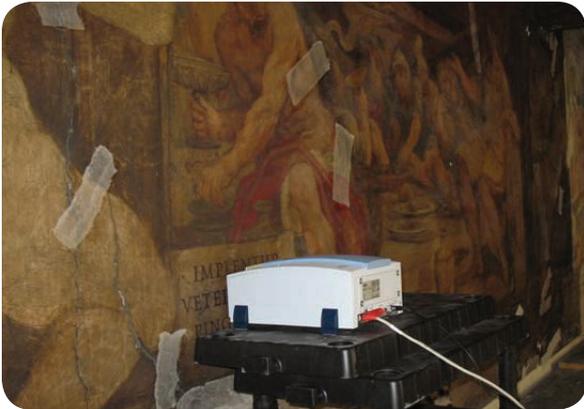
Figure 2: The ALPHA, equipped with a dedicated reflection module, is placed in front of the mural painting to perform the FT-IR measurements.

The ALPHA only takes up a 22cm by 30cm space, weighs about 7kg and can therefore easily be carried in a backpack.

As the ALPHA is insensitive to vibration, it can be placed almost anywhere, can be moved, and is immediately operational without any need for alignment. Equipped with a front-reflection module, which is designed for contactless and non-destructive FT-IR measurements, the portable ALPHA was placed in front of the mural painting (Figure 2). The ALPHA can also be placed on a tripod, the measurement position can be adjusted accordingly (Figure 8). In addition, the ALPHA's battery and wireless options enable extra portability features.

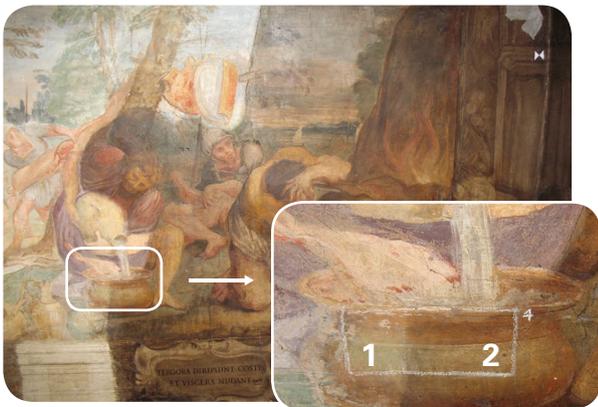
Figure 3: Detail of the mural painting during restoration process. Area 1: after cleaning; area 2: before cleaning.

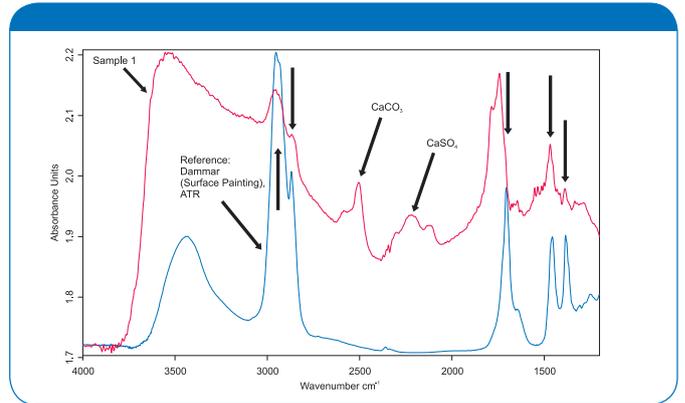
Figure 4: Spectrum of an area of the mural painting before cleaning showing typical absorbance of a terpenic varnish, calcium carbonate CaCO_3 and calcium sulfate CaSO_4 .

First, a spectrum of the mural painting before restoration was taken (Figure 4) and compared with a reference spectrum of a terpenic varnish (for example, dammar). Typical absorbance bands for terpenic varnish, calcium carbonate and calcium sulfate were identified. Subsequently, the same area of mural painting was treated with acetone and a new spectrum after treatment was taken to control the cleaning effectiveness. As seen on Figure 5, the terpenic varnish has been completely removed by the acetone treatment; the typical bands of varnish are missing in the spectra.

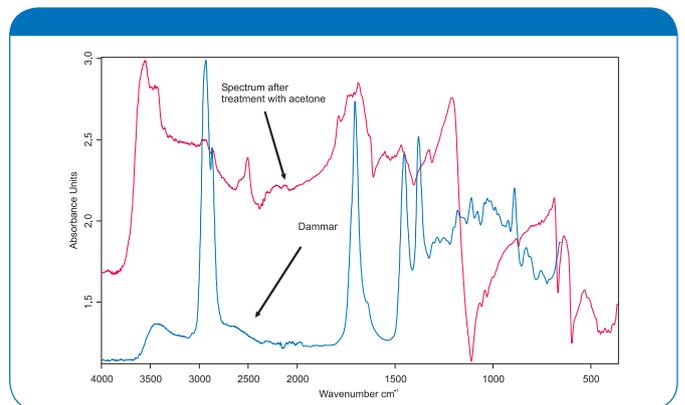
Figure 5: Spectrum (red) of the mural painting after treatment with acetone. The typical absorption bands of terpenic varnish (blue) are missing showing a successful treatment of the mural painting.

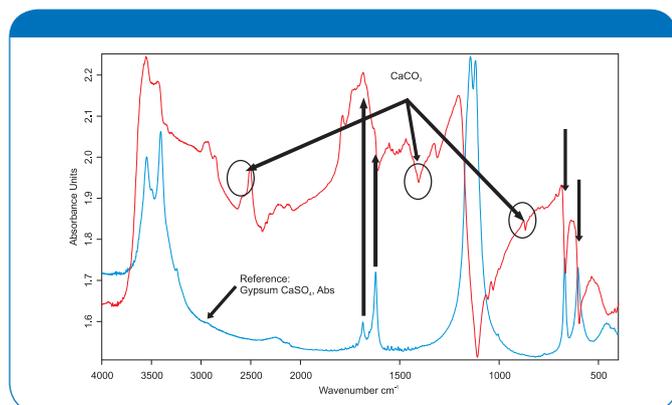
Figure 6: Spectrum (red) of the mural painting after treatment with acetone and comparison with a calcium sulfate reference (blue). Calcium sulfate and calcium carbonate are identified.

In addition, comparing the spectra of the treated mural painting with a spectrum reference for calcium sulfate (gypsum) from the library identifies the calcium sulfate and calcium carbonate (Figure 6).

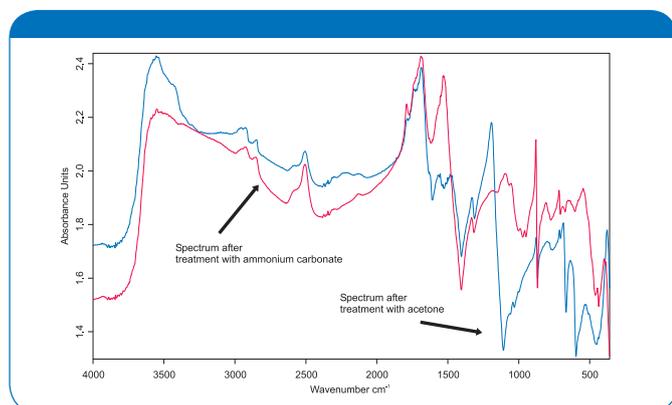
Figure 7: Spectrum of the mural painting after treatment with ammonium carbonate (red). Calcium sulfate was removed successfully. For comparison, the spectrum after treatment with acetone is displayed (blue).

Subsequently, one part of the mural painting was treated with ammonium carbonate to remove the calcium sulfate. Figure 7 shows the successful treatment on the mural painting surface by the ammonium carbonate treatment; no absorbance peaks of calcium sulfate can be identified after this treatment step.

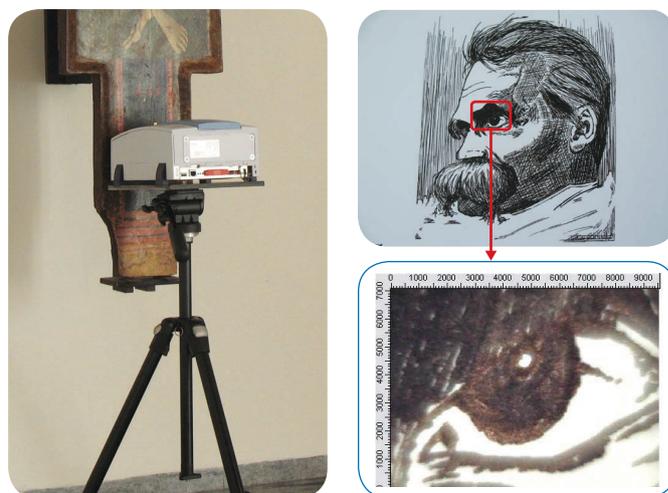
Figure 8: The ALPHA FT-IR spectrometer with the tripod option at "Pinacoteca Nazionale di Bologna" during material screening.
